UNDERWATER BRIDGE INSPECTION REPORT

STRUCTURE NO. 73536

SAUK RIVER

DISTRICT 3 - STEARNS COUNTY

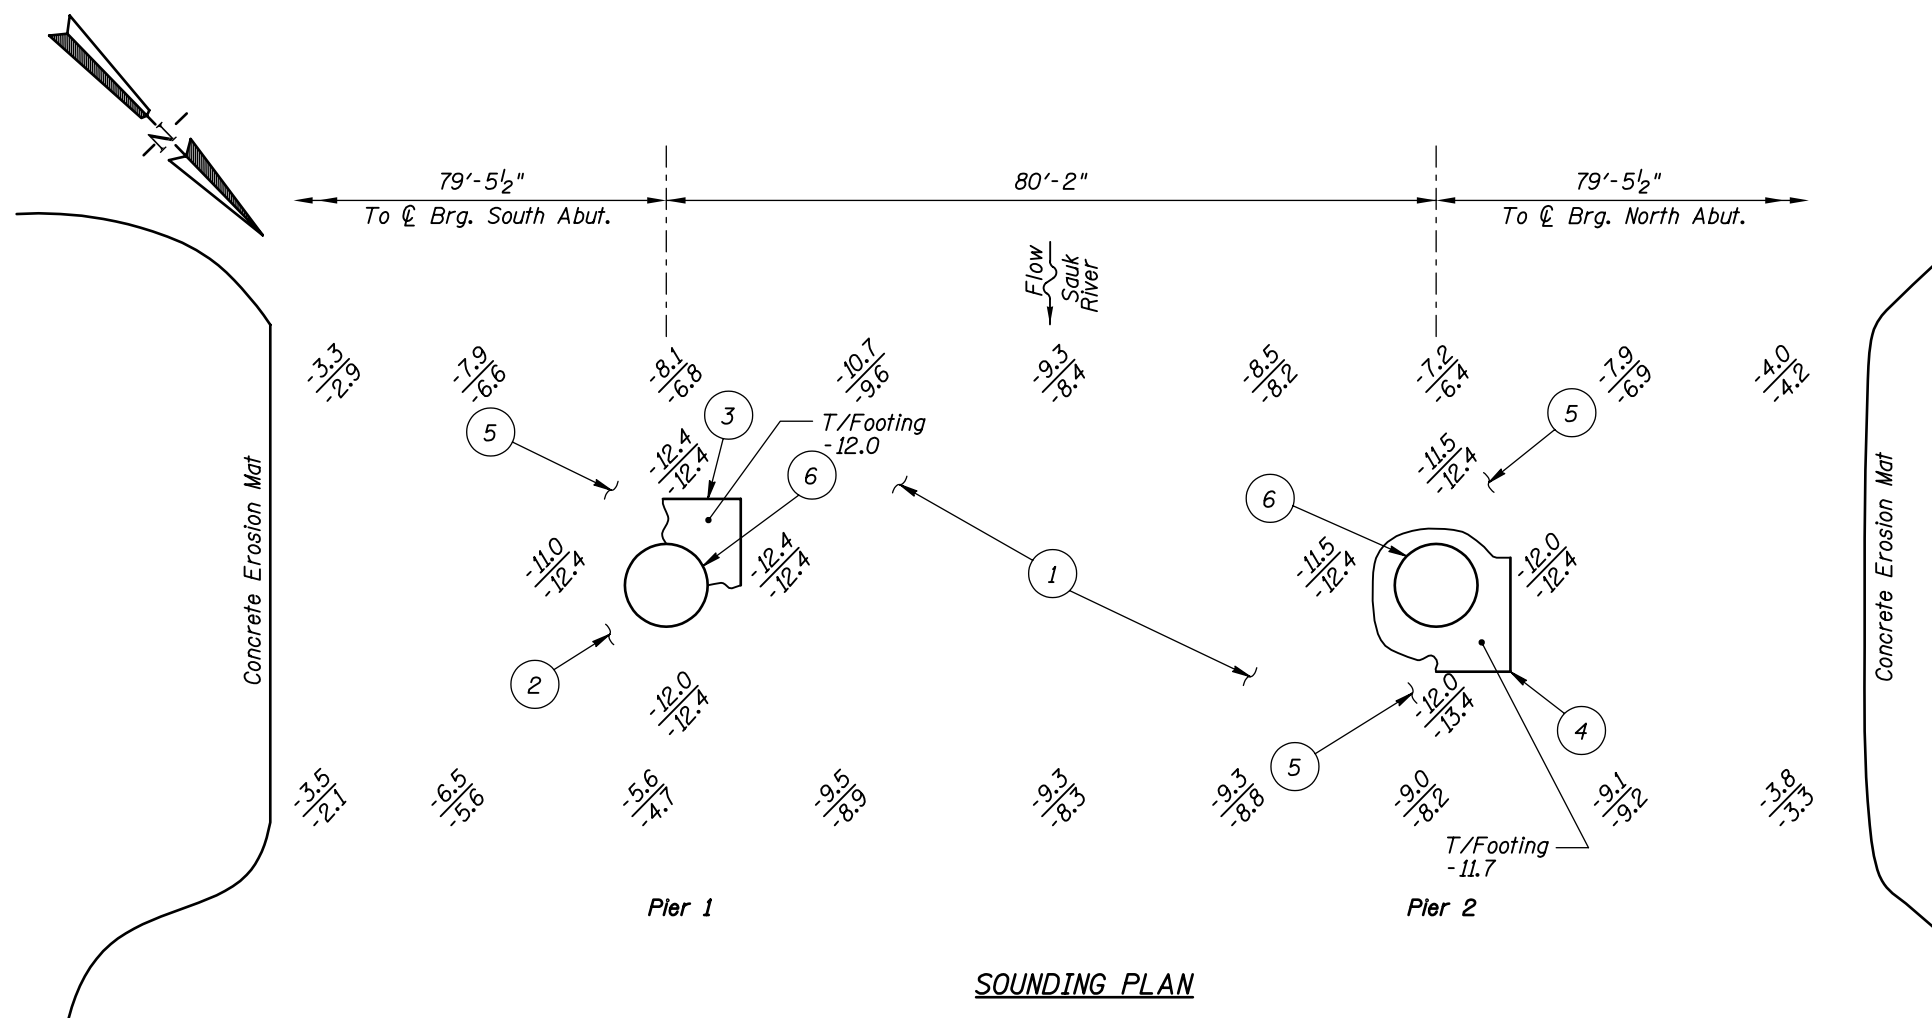
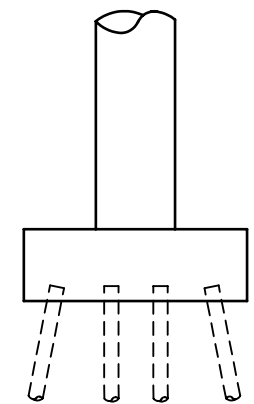
SOUNDING PLAN

- The channel bottom consisted of sandy gravel with up to 5 inches of probe rod penetration.
- The channel bottom consisted of sand with up to 8 inches of probe rod penetration.
- The top of footing was exposed at the western corner of Pier 1 with no vertical face exposed.
- The top of footing was exposed around the column and at the northern corner of Pier 2 with up to 1 foot of vertical exposure.
- Localized scour pockets, 4 to 5 feet deep, were observed around the pier columns.
- The submerged concrete was in good, sound condition with a light layer of aquatic growth observed.

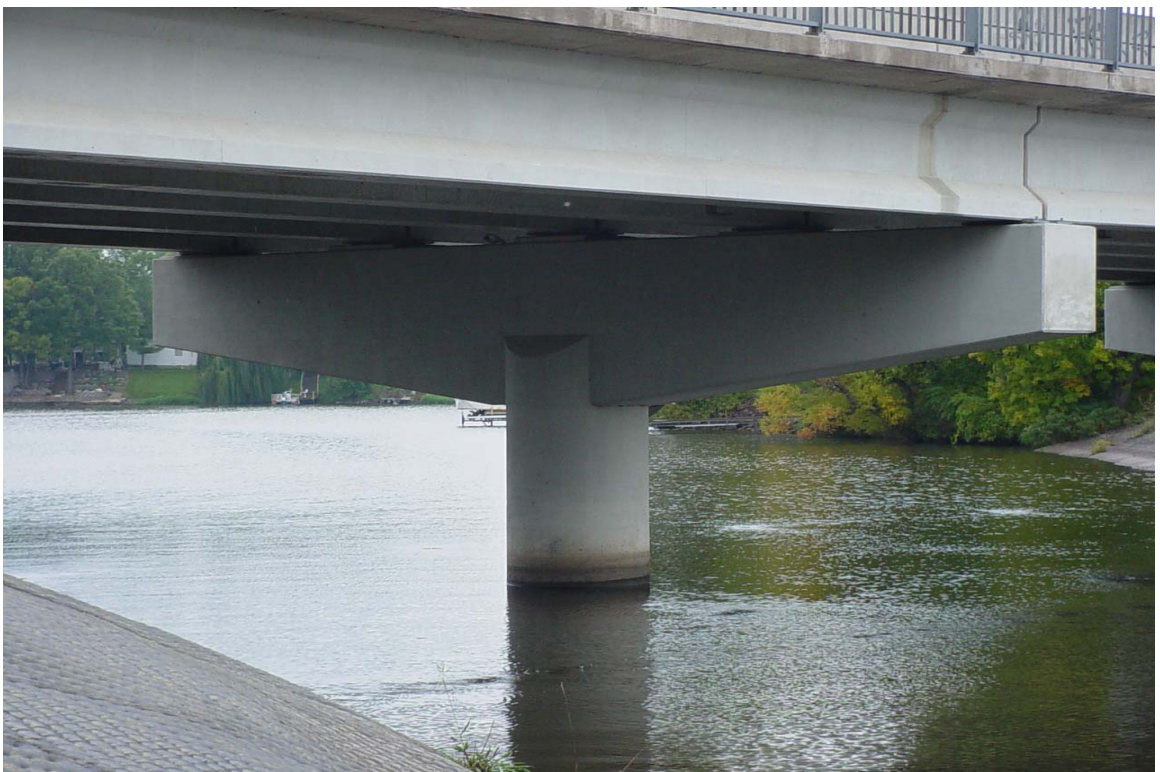
- (A) There was minor footing exposure encountered at both piers due to a minor amount of local scour. The footing at Pier 1 was exposed at the western corner with no vertical face detected. The footing at Pier 2 was exposed at the northern corner with up to 1 foot of vertical face exposed.
- (B) The Concrete of the piers was in very good condition with no notable defects.

Photograph 2. View of Pier 1, Looking Northwest.

- (A) Reinspect the submerged substructure units at the normal maximum recommended (NBIS) interval of five (5) years.

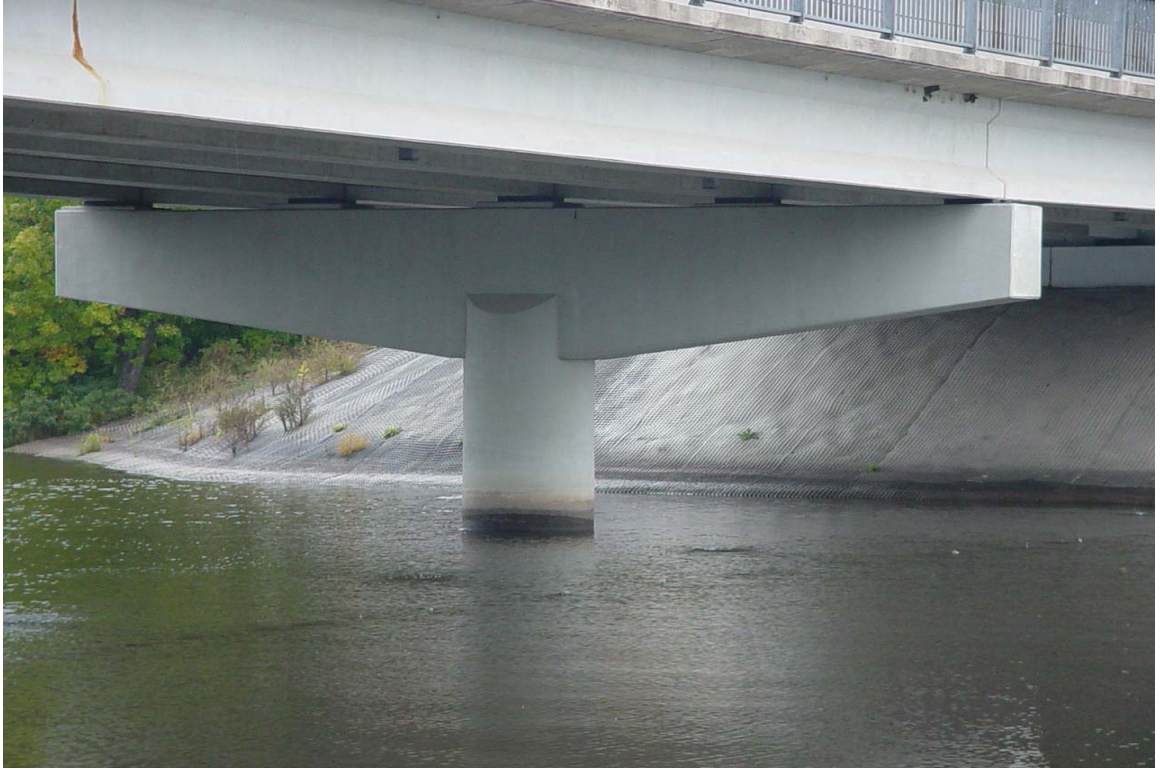
Photograph 3. View of Pier 2, Looking Northwest.
